PAPER MILL DAM  
NH 00251

PHASE I INSPECTION REPORT  
NATIONAL DAM INSPECTION PROGRAM

FEBRUARY 1979

Identification No.: NH00251  
Name of Dam: Paper Mill Dam  
Town: Bennington  
County and State: Hillsborough County, New Hampshire  
River: Contoocook River  
Date of Inspection: November 20, 1978

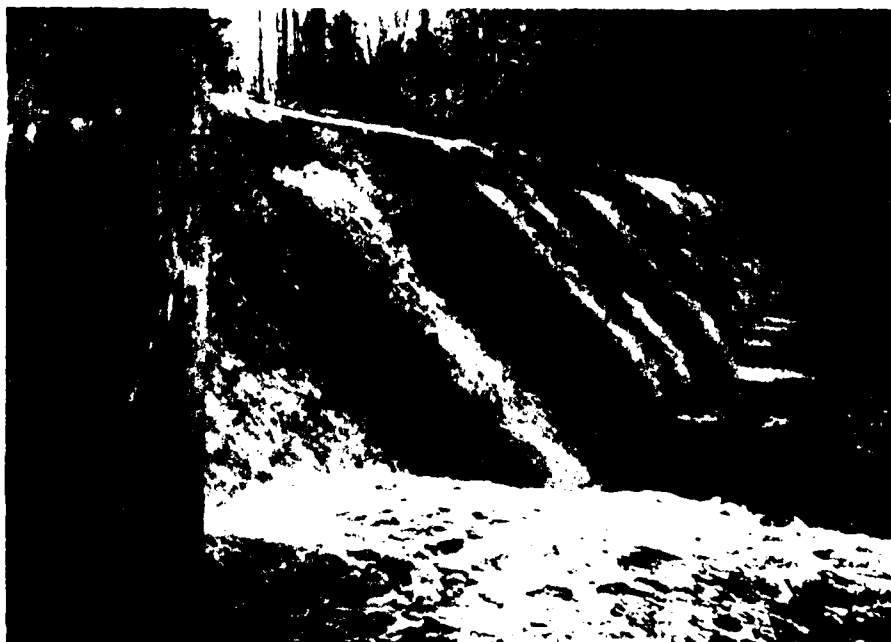
(1) Deterioration and erosion of the concrete in the main dam, particularly along the cold joints and at the non-overflow portion at the south abutment of the dam.

Figure 2 - Looking south along the upstream face of the spillway. Note the erosion of the concrete.

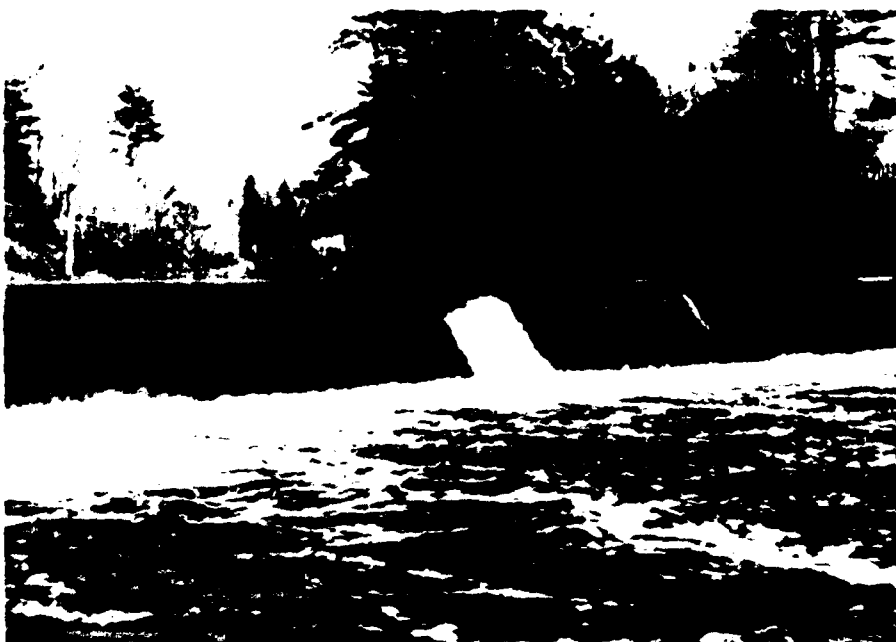
On a return visit to the dam on April 19, 1979 it was observed that a piece of the dam crest (approximately 2 cubic feet) had apparently spalled away near the center of the dam. The depression caused by the spalling is reflected in the water surface passing over the crest. (See Appendix C - Figure 15.)

Figure 15 - View of the eroded section of the dam crest.
